Dal sito di Agostino Ferrari - già presidente ANPAN - estraiamo questo ricordo bellico che crediamo di grande interesse per i nostri Associati.

B - 17 in 1943

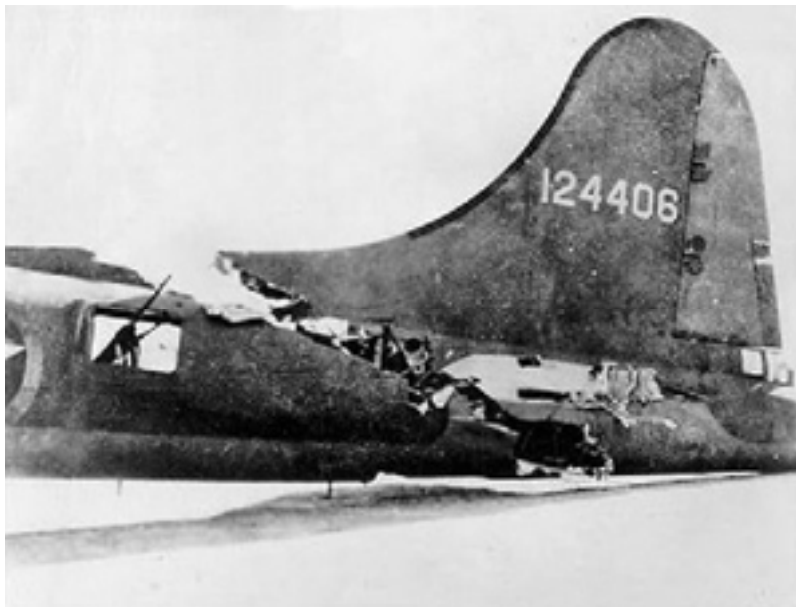
The left horizontal stabilizer of the Fortress and left elevator were completely torn away. The two right engines were out and one on the left had a serious oil pump leak. The vertical fin and the rudder had been damaged, the fuselage had been cut almost completely through connected only at two small parts of the frame and the radios, electrical and oxygen systems were damaged. There was also a hole in the top that was over 16 feet long and 4 feet wide at its widest and the split in the fuselage went all the way to the top gunners turret.

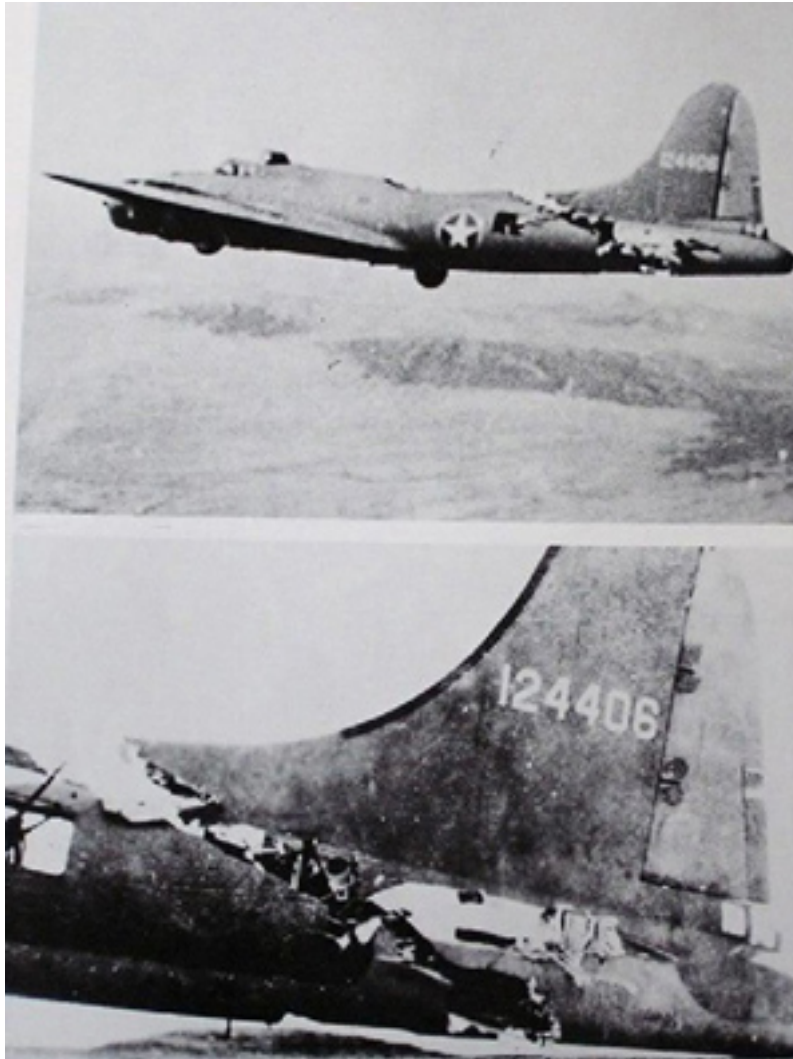
Although the tail actually bounced and swayed in the wind and twisted when the plane turned and all the control cables were severed, except one single elevator cable still worked, and the aircraft still flew - miraculously!

The tail gunner was trapped because there was no floor connecting the tail to the rest of the plane. The waist and tail gunners used parts of the German fighter and their own parachute harnesses in an attempt to keep the tail from ripping off and the two sides of the fuselage from splitting apart. While the crew was trying to keep the bomber from coming apart, the pilot continued on his bomb run and released his bombs over the target.
